## ADA Compliant Pedestrian Barricade Detail

### E.2 Detectable Pedestrian Barricades

## Appropriate Crosswalk and Sidewalk Closures with ADA Compliant Pedestrian Barricades

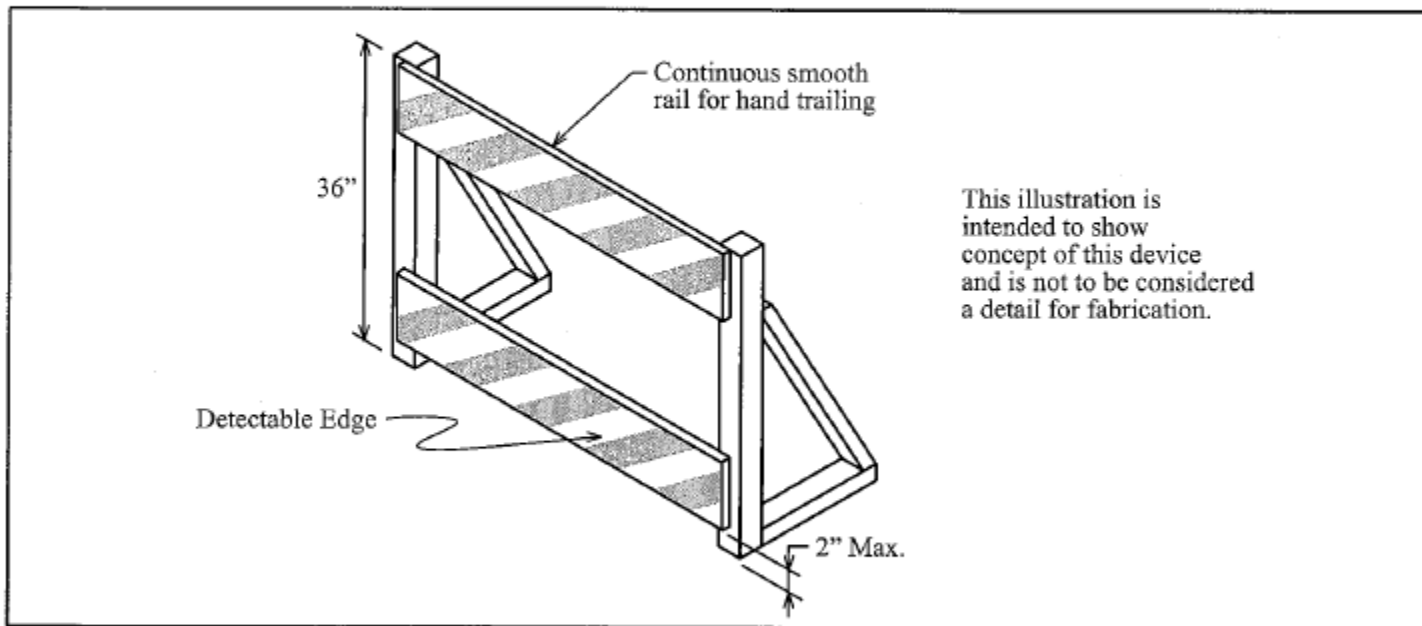
Figure E-2. Detectable Pedestrian Barricade

Detectable Pedestrian Barricades shall comply with the requirements of the Texas Manual on Uniform Traffic Control Devices (TMUTCD). Warning lights shall not be attached to the barricade.

- Safety Rail (Plastic Safety Systems, Inc.)

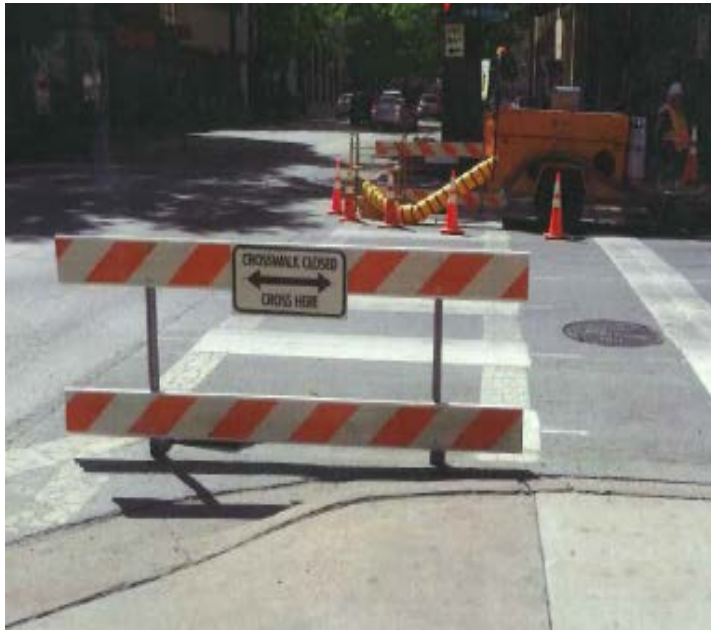
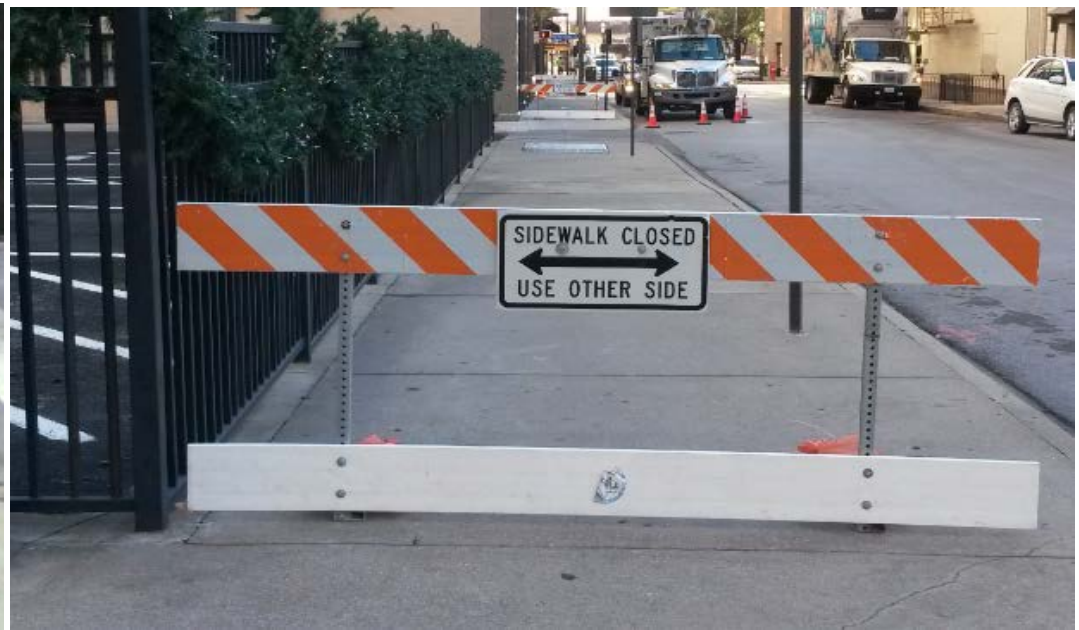
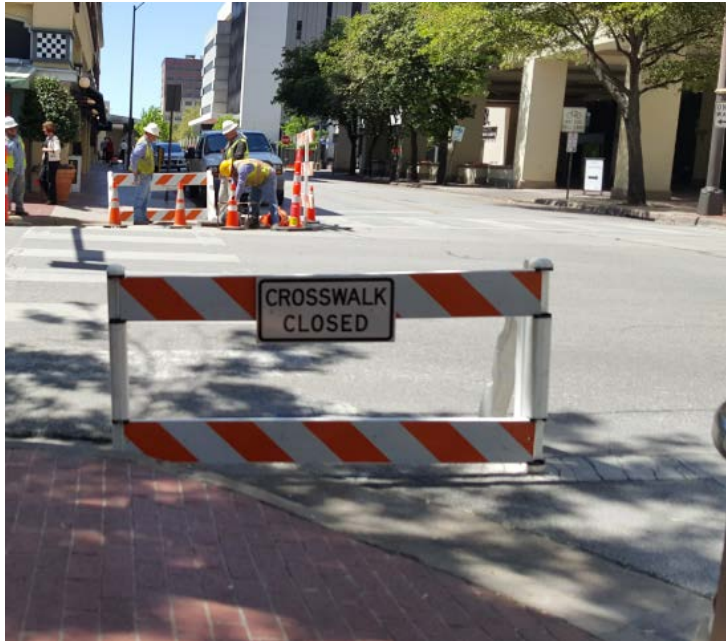
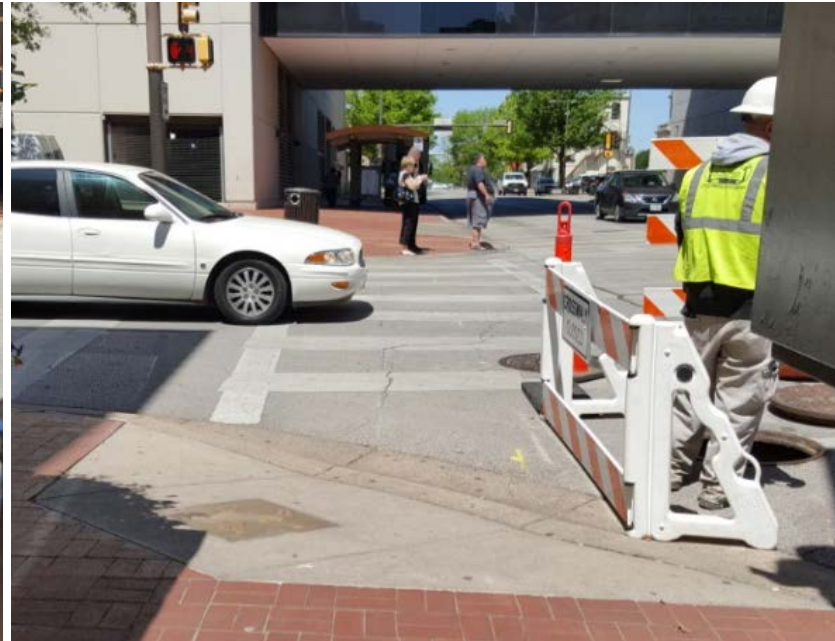
Barricades for Crosswalk Closures shall be set-up to allow impaired pedestrians access up/down ADA ramp and be lined up to ensure visually impaired pedestrians are directed safely.

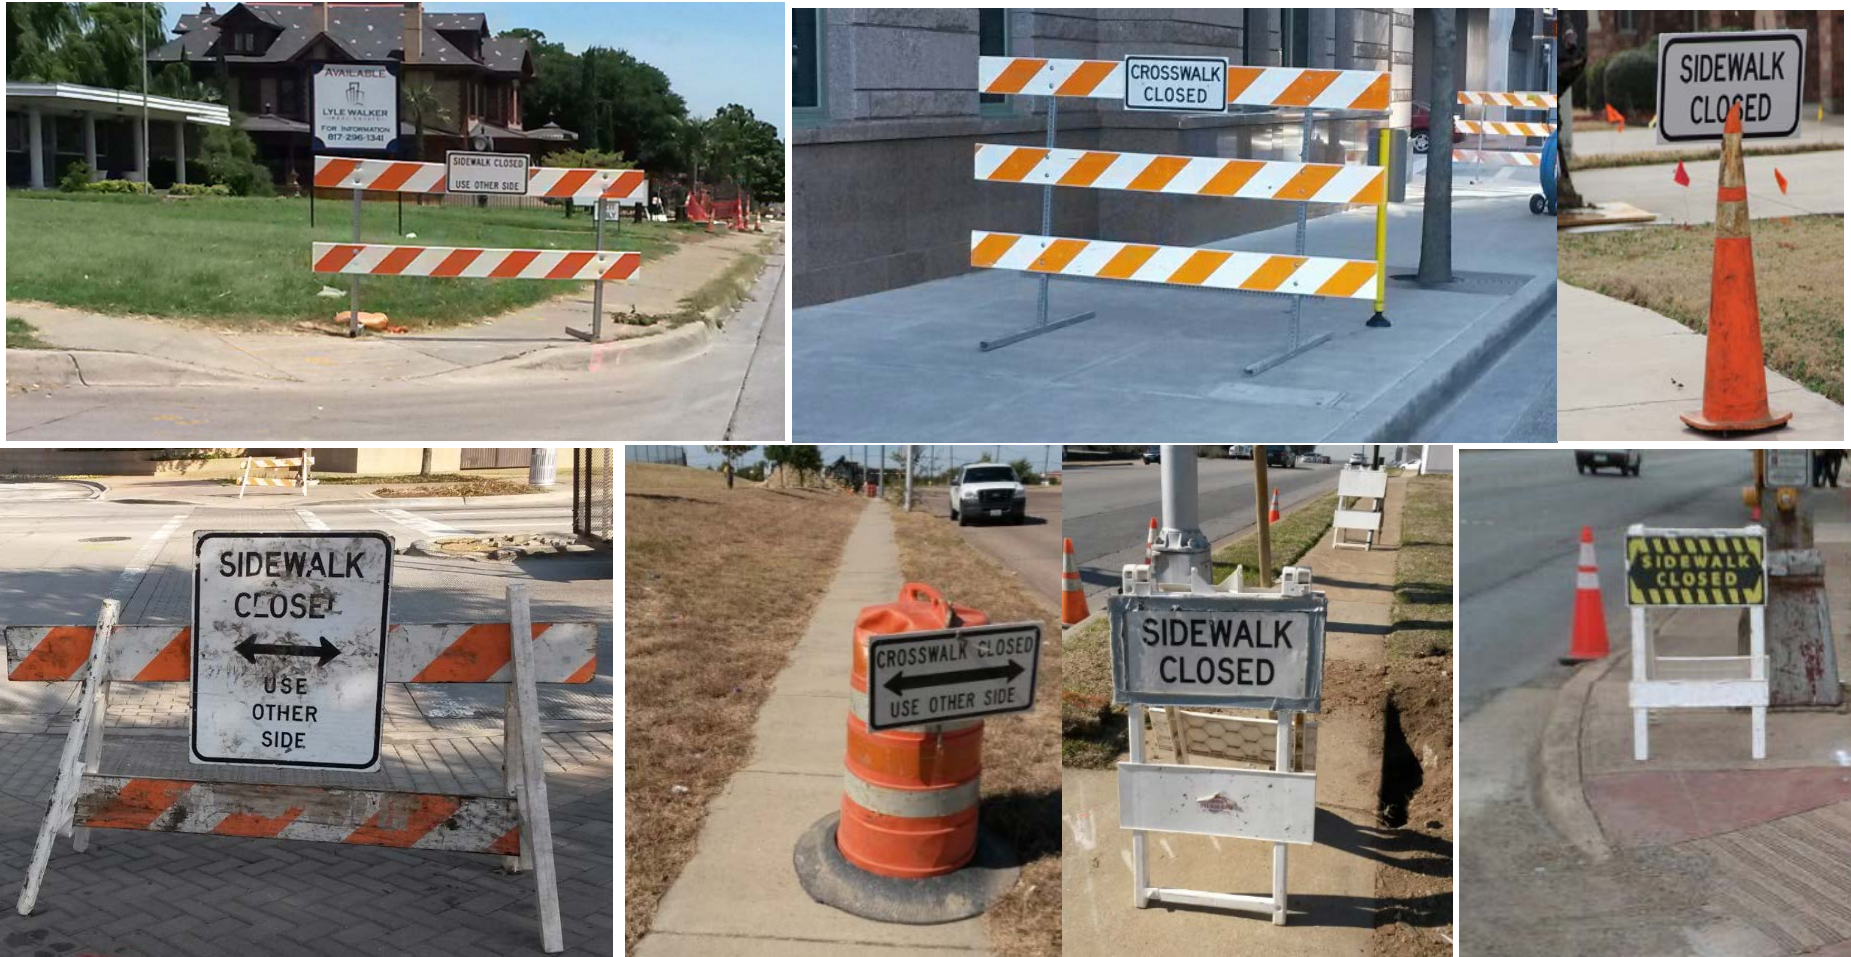
**BAD EXAMPLES of INAPPROPRIATE signs and barriers for pedestrian control**

Some of the bad examples do not comply with TMUTCD or ADA guidelines: wrong type of barricade, wrong sign or poor quality. Refer to the TMUTCD or ADA requirements/guidelines for more details and examples.
