City of Fort Worth

# 2021 Annual Report

TPDES Permit # WQ0004350000

Permit Year 4: March 8, 2021-March 7, 2022

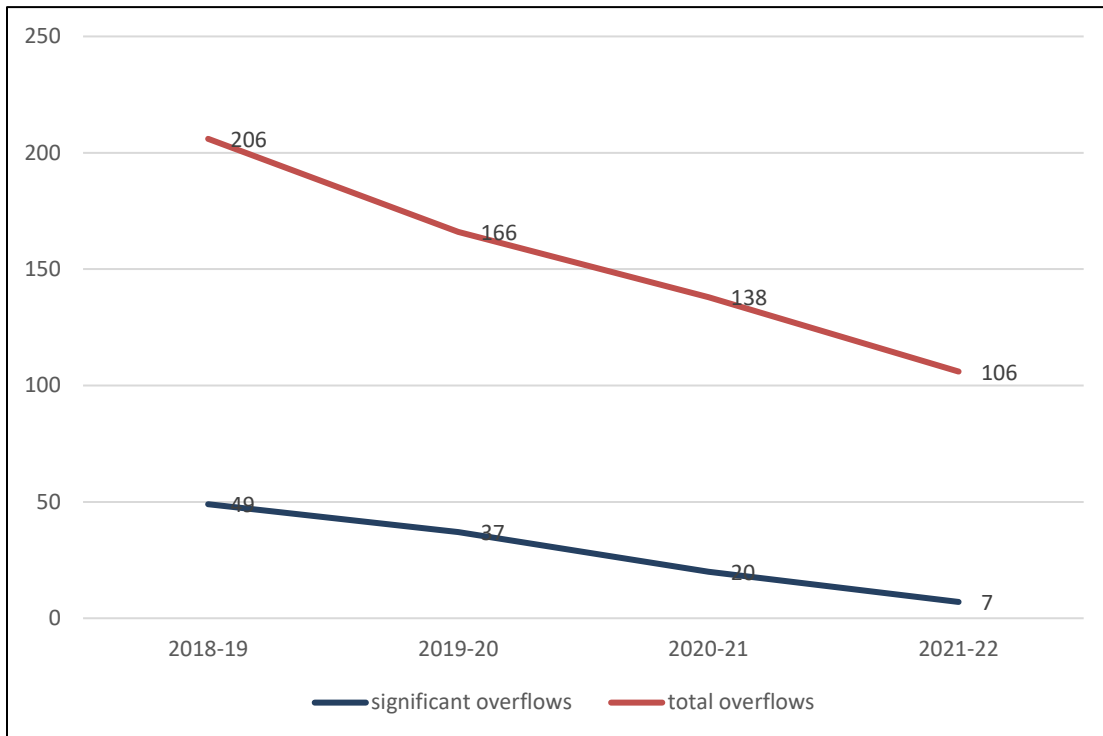
**Figure 6. Number of sanitary sewer overflows during permit years 1-4.**

The total number of sanitary overflows, the number of significant overflows (SSOs, >50,000 gal), as well as the number of gallons associated with each, has decreased throughout the first through fourth permit years (Figures 6 and 7). This is an important BMP tracked towards decreasing bacteria entering the creeks and working toward the WLA goal number. Additionally, there were only a total of 4 SSOs within the TMDL watersheds, with three considered to be significant overflows (Figure 8). Improvements to the sanitary sewer along Sycamore Creek are currently in progress and are planned to be completed this year.

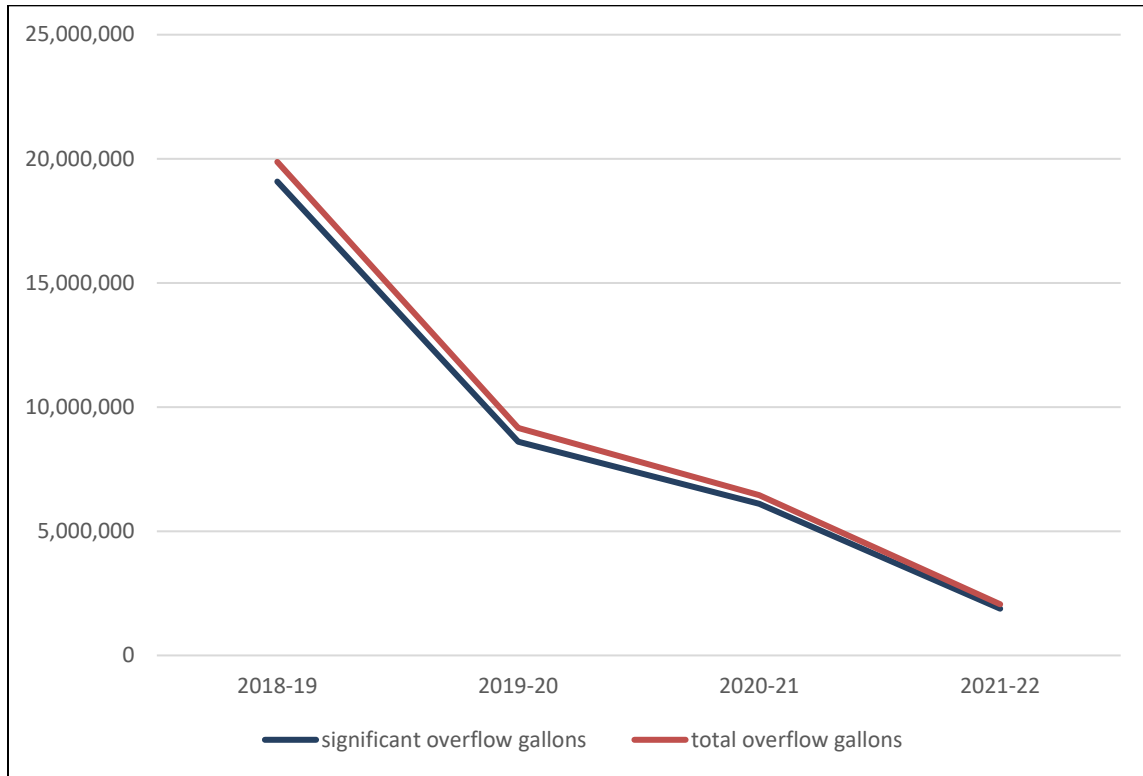
**Figure 7. Sanitary sewer overflows in gallons during permit years 1-4.**

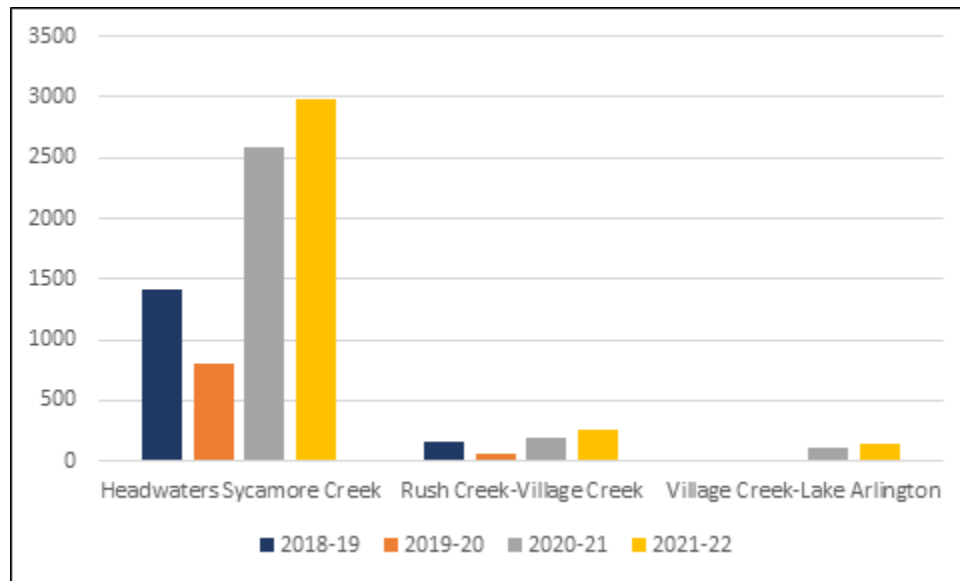
**Figure 9. Illegal dump sites in Headwaters Sycamore Creek, Rush Creek-Village Creek, and Village Creek-Lake Arlington watersheds TMDL Areas.**

This permit year, the Code Compliance Department collected 8,313 illegal dumps at 4,018 total tons. That’s an increase of 7.5% total tons from last year’s collection of 3,736. As indicated in Figure 9, there was also an increase in the number of collected illegal dumps in the Headwaters Sycamore Creek, Rush Creek-Village Creek, and Village Creek-Lake Arlington watersheds.

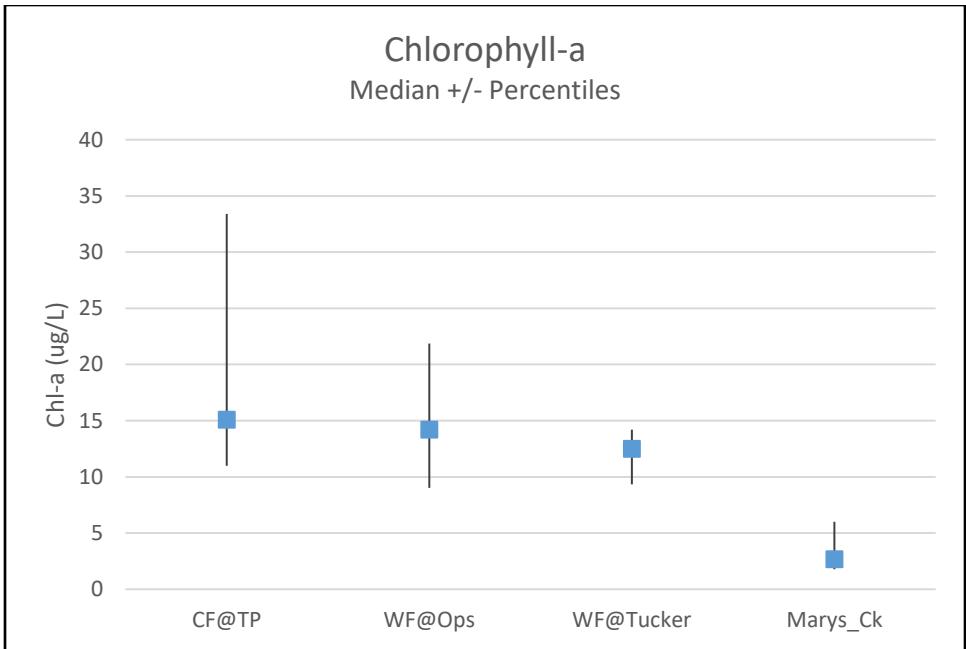
Figure 2 – Chlorophyll-a Medians and Percentiles for Primary River Sites

Routine monitoring of the Trinity River involves 3 primary river sites and one major tributary site where a full suite of parameters is collected. One new site was added to this program during the reporting period. The first section of canal was completed and a sampling station has been established to monitor the water quality with the same parameters as the river. The parameter suite includes Chlorophyll 'a', TSS, TDS, Nitrogen series, Phosphorus series, TOC, Chlorides, CBOD, *E. coli*, Silica, and Phytoplankton Enumeration. There are 5 additional sampling locations that are *E. coli* only, for a total of 9 monthly sampling locations. In-situ field measurements are recorded for temperature, pH, dissolved oxygen, specific conductance, and turbidity at all 9 monitoring stations. See Figures 2-7 for charts for a comparison of the major river sites. The data collected under this program is intended to capture a variety of hydrologic conditions. It is collected on a scheduled monthly basis and is not targeted towards high runoff events specifically.

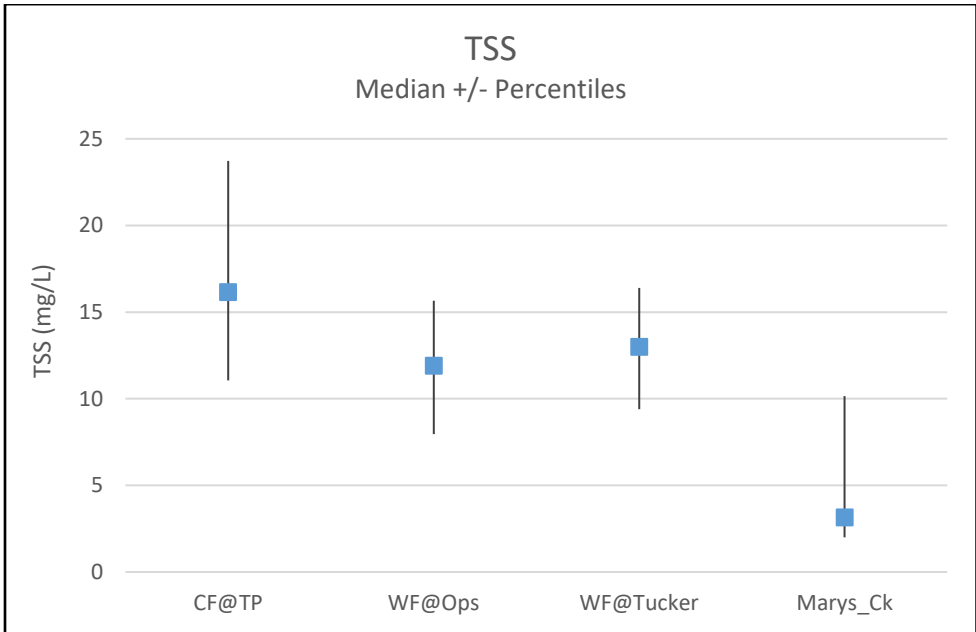
Figure 3 – TSS Medians and Percentiles for Primary River Sites

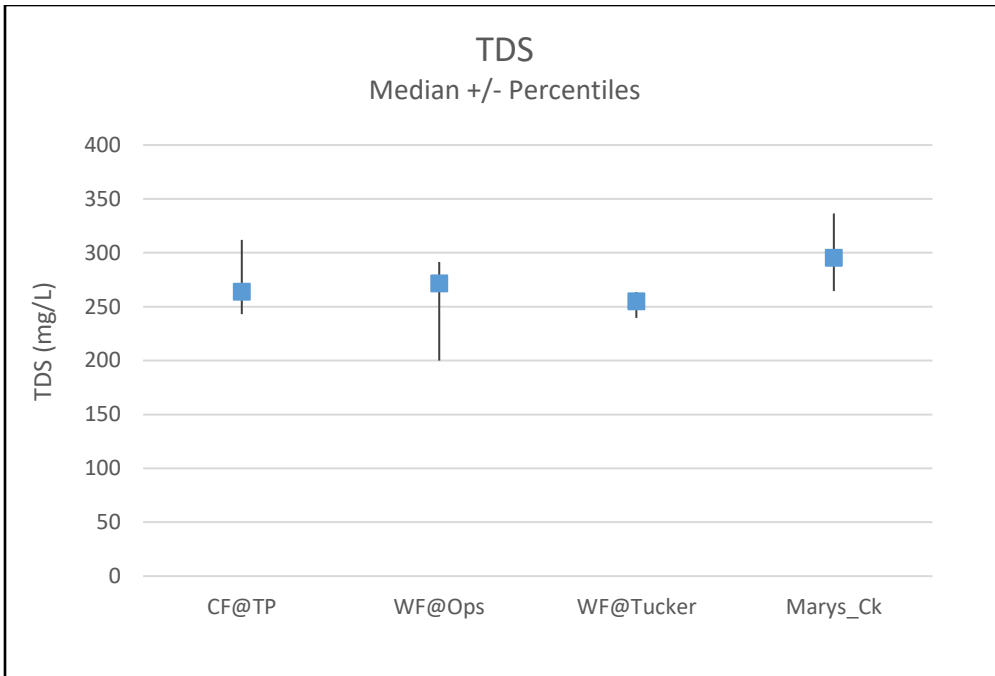
Figure 4 – TDS Medians and Percentiles for Primary River Sites

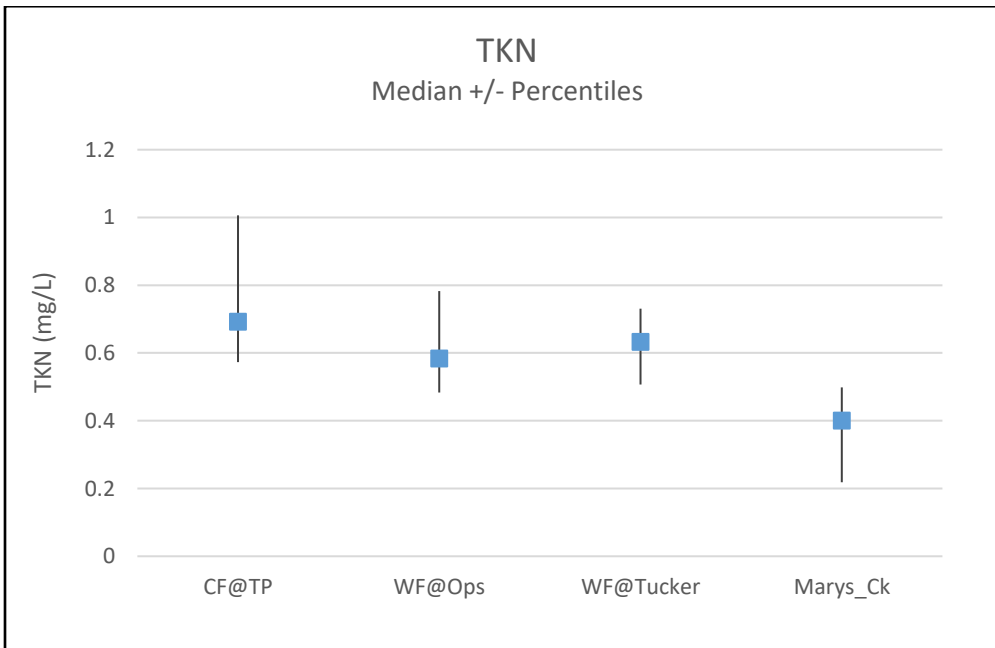
Figure 5 – TKN Medians and Percentiles for Primary River Sites

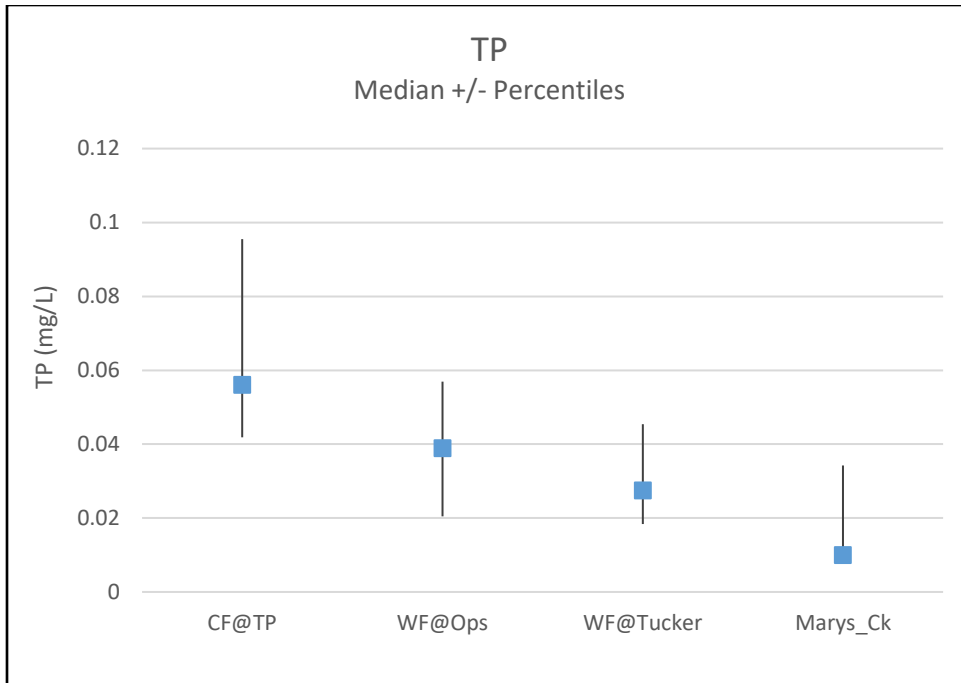
Figure 6 – TP Medians and Percentiles for Primary River Sites

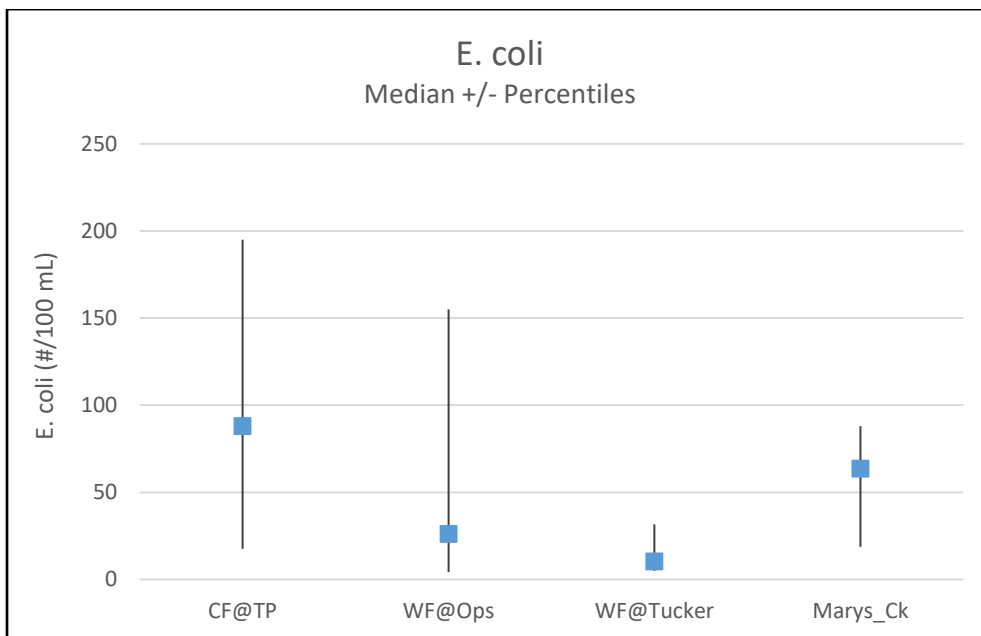
Figure 7 – E. coli Medians and Percentiles for Primary River Sites
